Understand Why One PD Method May Be Better Than Another

By Greg Linton, HV Diagnostic Services Limited

The following account is from a major wind generation site located in the North Island of New Zealand whereby a termination failure occurred within the LV Box (33kV) on one of the two identical 90MVA Station Transformers approximately 6 months after commissioning.

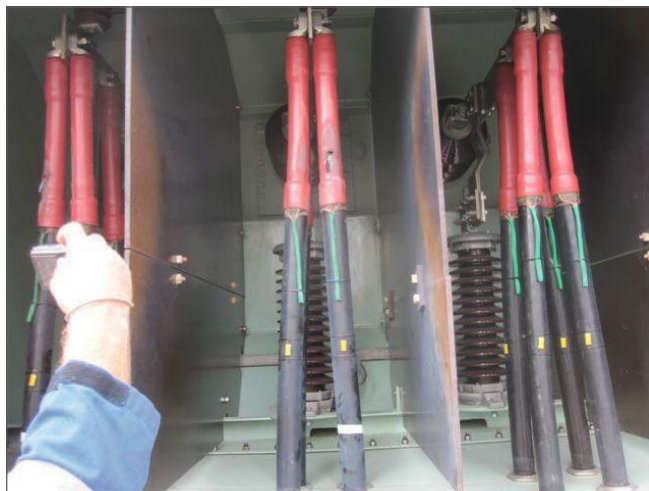
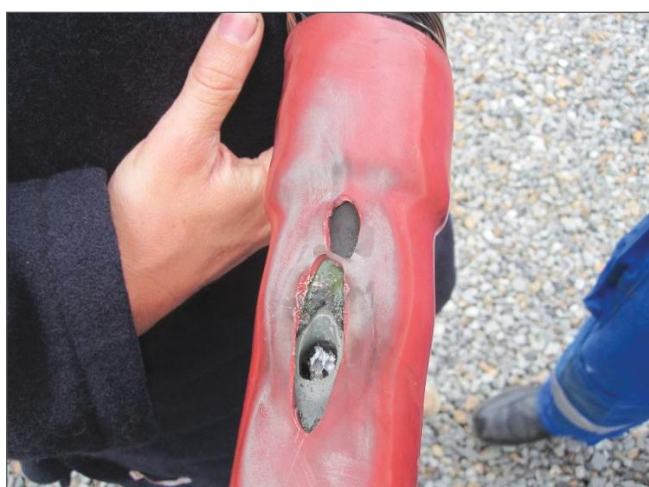
11kV Busbar erupted Insulation due to non-uniformity

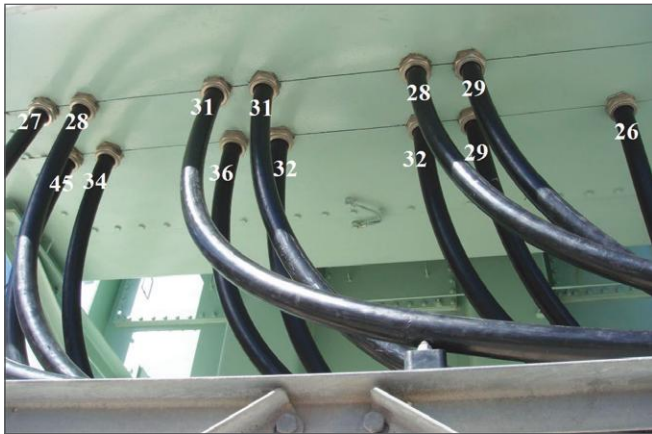
Unfortunately no as a second failure occurred around 11 months later with termination failure in an identical position as before, located just above the grading tape at the semiconductor cut off.

After further repairs (including testing Insulation Resistance, PI, sheath insulation resistance etc with good results) it was at this point that HVDS was asked to perform a PD survey on the Transformer Termination Boxes on the 16 Feb 2011. TEV results revealed a significantly higher level, 34 vs 9dBmV on the problematic Box as compared to its stablemate (plus excessive severity which also takes discharge pulse rate into account) leading to each of the 12 cables (4 per phase) being measured individually as shown in Figure 1.

Figure 1 (the number superimposed on each cable represents the measured TEV value in dBmV)

Following this revelation the asset owner made the challenging decision to replace all 33kV terminations on T1 thereby placing a constraint on the parks output for a considerable period of time, and a further survey on T2 (with T1 out of service) on the 25th May 2011 confirmed both the abnormality on T1, but also proof that the risk of something similar occurring on T2 was low, Figure 2.

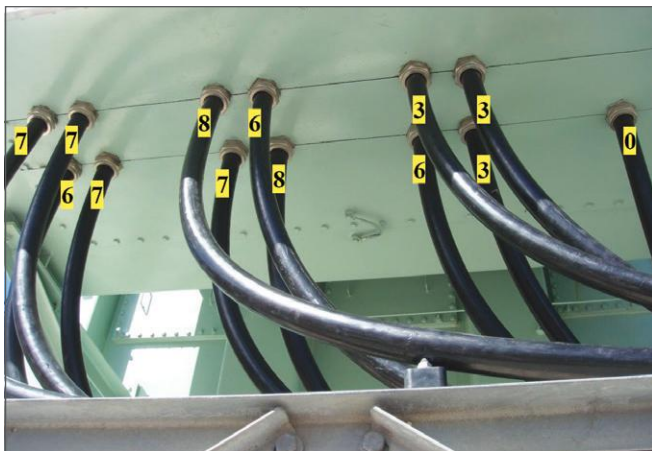
Figure 2 T2 exhibits no indication of Internal Discharge problem

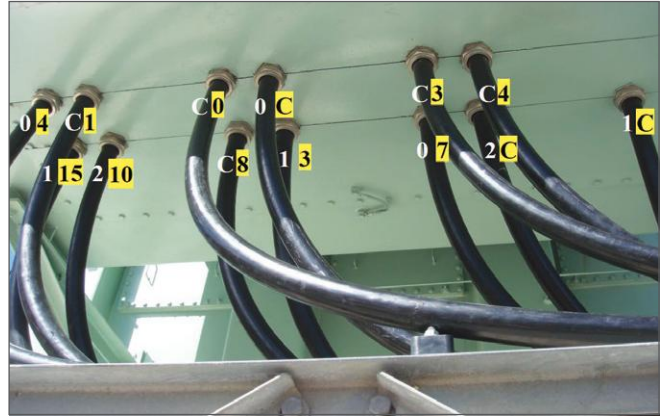
With both transformers having ultimately been returned to service follow-up tests were carried out in both September and October 2011 under differing load and ambient conditions with results between the two now significantly more uniform and directly comparable, Figure 3.

Figure 3 September results - Both Transformers in service post T1 Termination replacement
