# **Practical Partial Discharge Mitigation on Reyrolle LMT 11kV switchgear**

EEA Conference and Exhibition 2015, 24 – 26 June, Wellington

George Albuero  
Asset Engineer  
Wellington Electricity Lines Limited

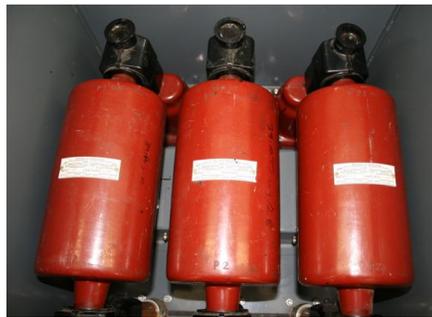
**Resin Encapsulated CTs**

Partial discharge testing on LMT switchgear indicated potential issues around the current transformer (CT) chambers on units with resin encapsulated CTs, with some sites generating levels as high as 50dB. While the magnitude of partial discharge was

Reyrolle LMT switchgear used a one-piece cast resin CT and primary bar assembly on most equipment from the late 1960s to the 1990s, when they changed to a screened primary bar with slip on CTs. Voids created during the resin moulding process are thought to be the main cause of the discharge on these components.

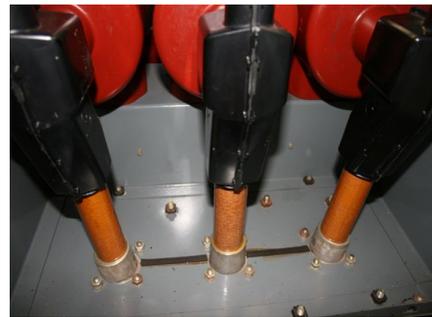
**SRPB Bushings**

As the project proceeded, further issues were identified with cast epoxy resin risers and synthetic resin bonded paper (SRBP) bushings between the CT compartment and cable box. There are also instances where partial discharge was occurring in heatshrink cable terminations where the cable boxes had been converted from a compound-filled box to an air box, without adequate clearances being maintained between the phases of the termination. In some instances the source of the partial discharge was the circuit breaker truck itself. Examples of these components are shown in Figure 1.

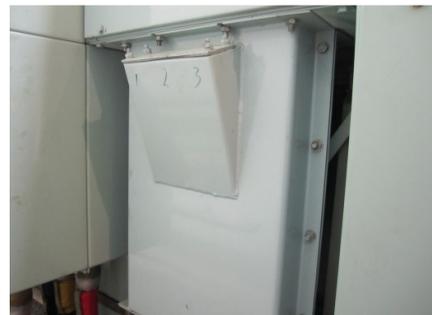
**Compound Box Converted to Air Box**

Discussion with the switchgear manufacturer and field investigations led Wellington Electricity to suspect that the cast epoxy resin riser and SRBP bushings between the CT chamber and the cable box were also exhibiting PD. Similarly, PD levels were also high on compound cable boxes that had been converted to an air-box using heatshrink terminations.

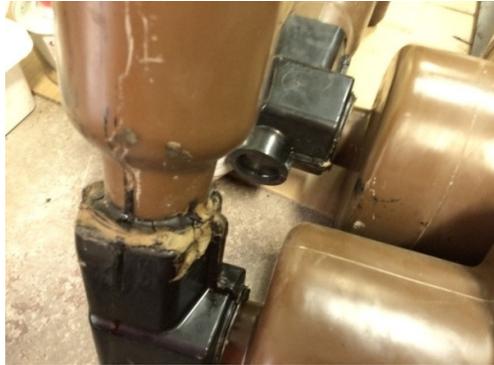
From replaced CTs, visible signs of surface tracking were observed on the monoblock riser, as shown in Figure 3. This indicated that, while the magnitude of partial discharge was not increasing, the potential for failure still existed and the replacement of components was justified.

**Figure 3 –Damage on Monoblock Riser due to PD at Waitangirua CB3**

The project involved replacement of the resin encapsulated CTs, SRBP bushings, and pitch-filled cable termination with retrofit components specifically developed for Wellington Electricity by the switchgear manufacturer. This significantly improved the partial discharge and tan-delta results, given in Figure 2, and confirmed that the retrofit was effective in addressing the risk.

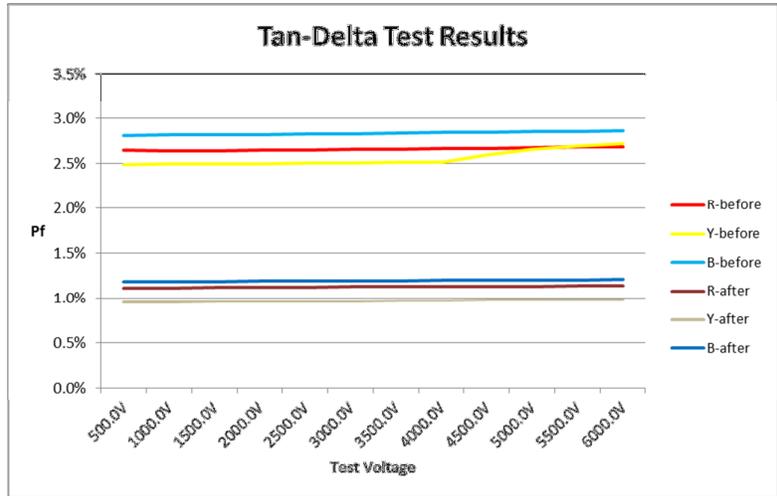
From 2013 to 2014, partial discharge mitigation using the retrofit kits was completed at the seven substations identified. Example partial discharge and tan-delta test results on Moore St CB12 are shown in Figures 7 and 8, demonstrating the effectiveness of the corrective measures.

**Figure 8 – Results of Tan-Delta Testing of Moore St CB12, Before and After Mitigation**
