ULTRASONIC OR TEV?

By Greg Linton, HV Diagnostic Services Ltd

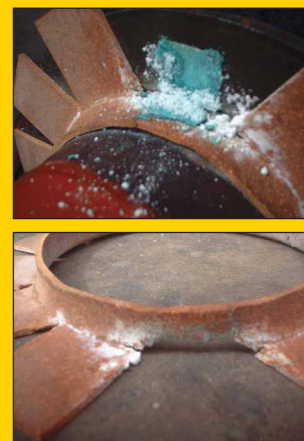
Figure 1

A routine substation survey in August 2004 located a discharge of 20% FSD from the breather of a CT chamber. This activity, originally measured at 12% in 2002, was definitely on the increase and the deterioration is typically exponential-like as the discharge gains momentum. The TEV readings quite rightly appeared normal and were unchanged from previous surveys. An inspection under a scheduled outage discovered discharge surrounding an earthing shim between layers of gasket material of the CT (see figure 1). The faulty component was replaced and a subsequent re-test has shown the installation free of any discharge activity.

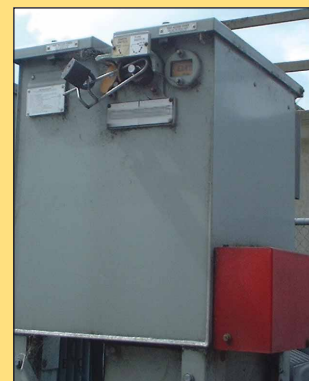
Figure 2

The annual visit to a Waikato Industrial site towards the end of 2004 revealed an unexpected increase in levels to one substation over the previous 12 months. The highest reading was recorded on the unused busbar end cap of an oil filled fuse switch (see figure 2). Although the background level was unchanged, indicating it was not external noise, the discharge was affecting all readings on the switchboard (see figure 3). The decision was made to replace the offending switch in a controlled manner prior to the beginning of their busy season. An investigation by the switch manufacturer confirmed that they found the likely source of the discharge around the teflon washers installed on the end of the buss connectors under the red cover identified. The substation was again surveyed in Feb 2005 with the readings returning to the levels previously recorded.
