Case Study 1

TEV discharge from termination / CT Chamber

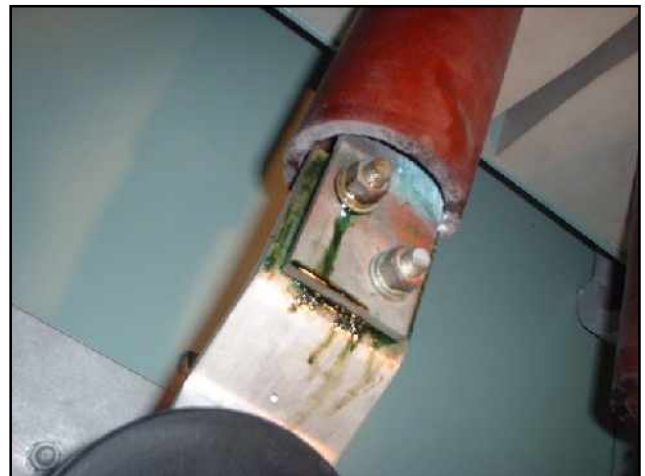
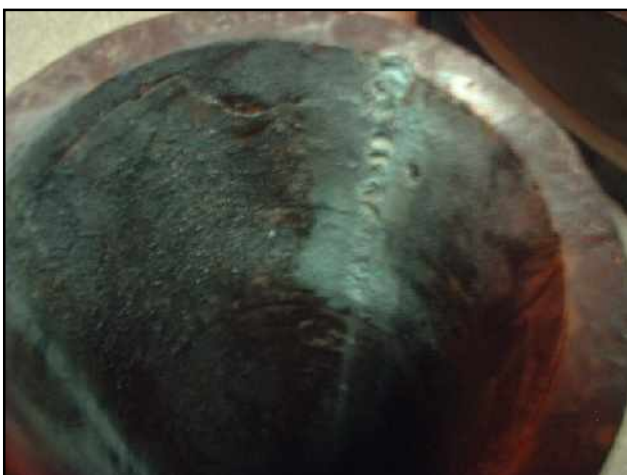
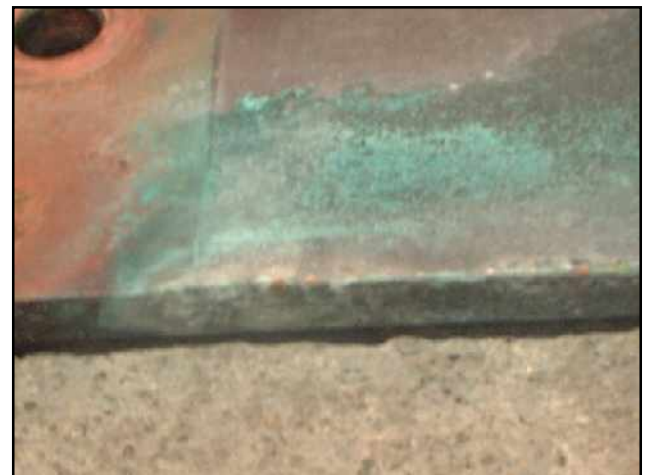
The initial survey in 2002 showed high readings centred about Feeder 5A. Despite the higher switch tank, double probing picked the termination.

These photos show the discharge as uncovered prior to any remedial action. It is thought that moisture absorption by the aged insulating tube may have been the cause initiating this partial discharge activity.

The grooves on the inner surface of the tube, and 'blunting' to the bar edge shows the deterioration that is possible when insulation begins to breakdown.

Under a scheduled outage an investigation & cleaning was undertaken. A re-test shows the dramatic improvement including a reduction to the recorded background.

Ongoing monitoring is conducted annually.
