Case Study 2

Ultrasonic discharge between Cable Shutters & Switch Tank

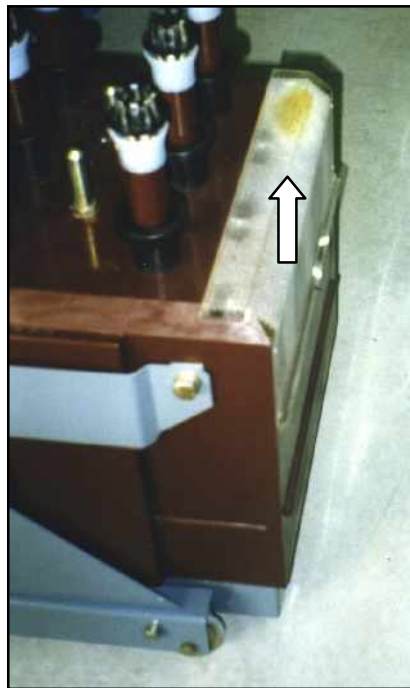
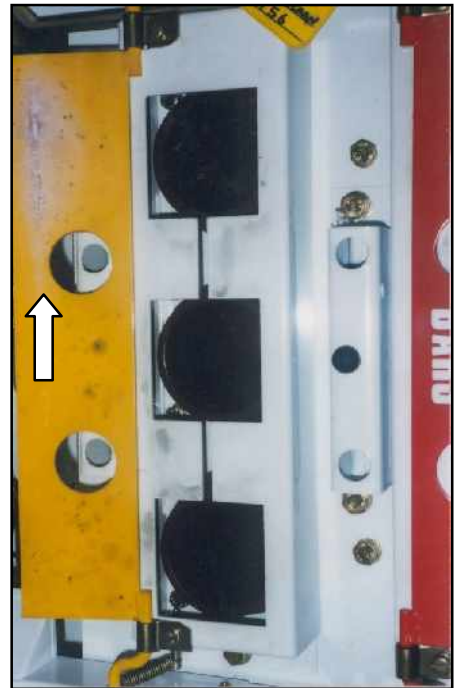
A Partial Discharge survey in 1998 detected an Ultrasonic signal of 30% at Gain 11 from above the Switchtank of a vacuum breaker. An investigation was undertaken and it was discovered that the shutter mechanism was not operating correctly, and consequently the shutter was in contact with the resin casing of the tank.

Discharge activity has caused the migration of yellow paint from the Cable shutter to the mesh on back side of Switch Tank.

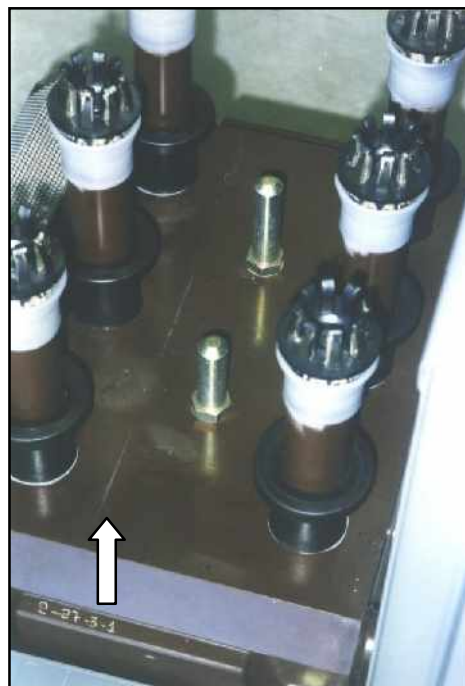
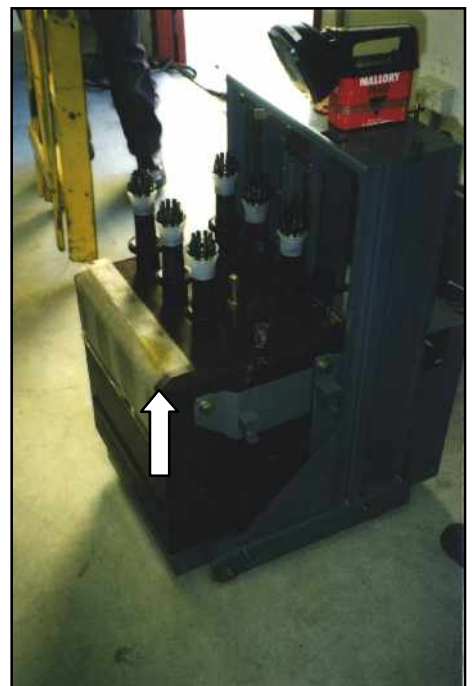
The Busbar Shutter was also in contact with the top of the resin surface as can be seen by the line running across it.
