Case Study 3

TEV discharge within a sealed Air Termination Box

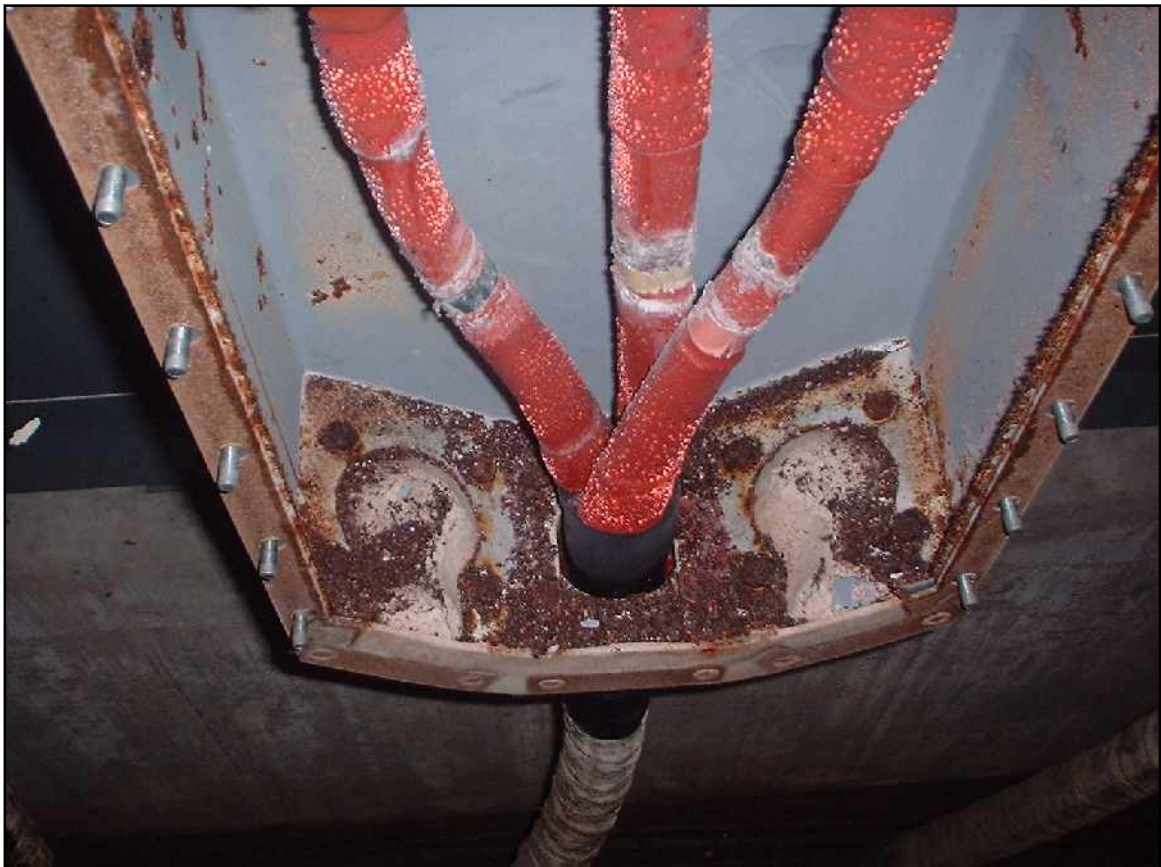
The Partial Discharge survey of a switchboard in 2000 showed higher than normal readings from the Switch tank and Termination Box as shown to the right. Subsequent double probing indicated the source was the termination box and an investigation was planned.

METAL WORK						8	
BUSBAR 1 UPPERFRONT	BUSBAR 2 LOWER/REAR	SWITCH TANK	CT CHAMBER	VOLTAGE TRANSFORMER	TERMINATION BOX	BAND JOINTS /END CAPS	
						BUSBAR 1	BUSBAR 2
9		16	7		10	13	
10		9	8		10		
10		12	6		12		
9		15	8				
11		18	10		23		
16		28	18		28		
19		16	4		19		
						14

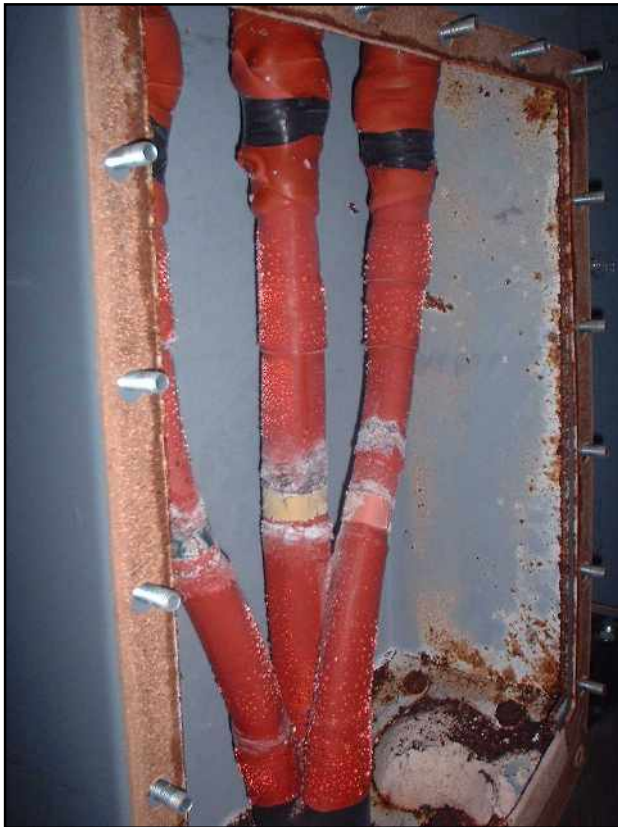
October 2000

As the box was sealed, a lack of ventilation allows for a build-up of gases. Nitrous oxide combining with water forms Nitric acid and is responsible for the Box rusting from the inside out. Dry Banding around the insulation tape fitted to each core is also evident and may have initiated this activity in the first place. This damp environment unable to breathe is perfect for nurturing Partial Discharge activity.

The gasket was removed, however the level of damage would require a full shutdown at a later date to address all the problems and the following before and after shots are taken approx 10 months apart.

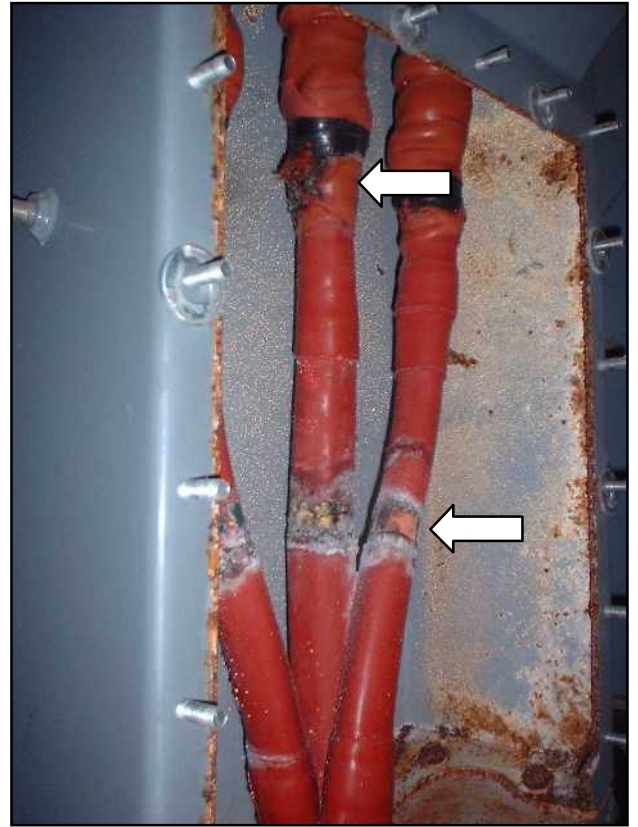
August 2001

Note the deterioration to the coloured insulating tape and the “blow-out” on yellow phase where the black insulating tape is fitted to the heatshrink tape. Closeups are shown below.
