Case Study 4

Ultrasonic discharge from Resin top of Switch Tank

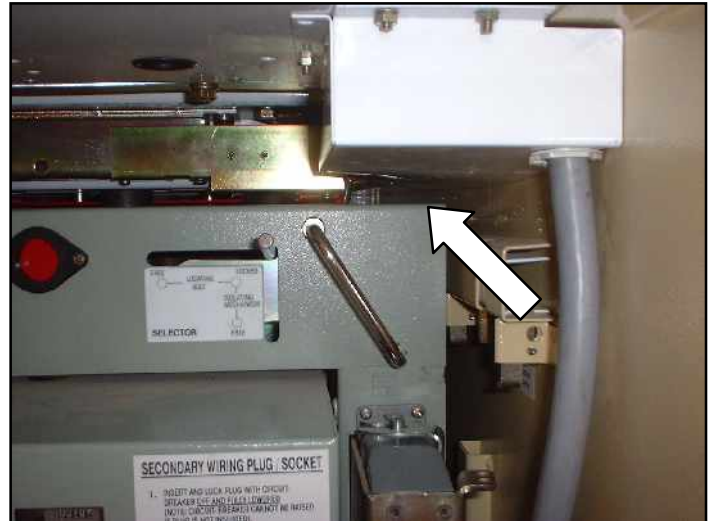
The annual Partial Discharge survey of a switchboard in 2003 revealed Ultrasonic activity from above the Switch tank on a year 2000 vacuum circuit breaker. A reading of 50% at gain 11 was recorded which was strongest from the top right hand corner indicating the location of whatever was at fault.

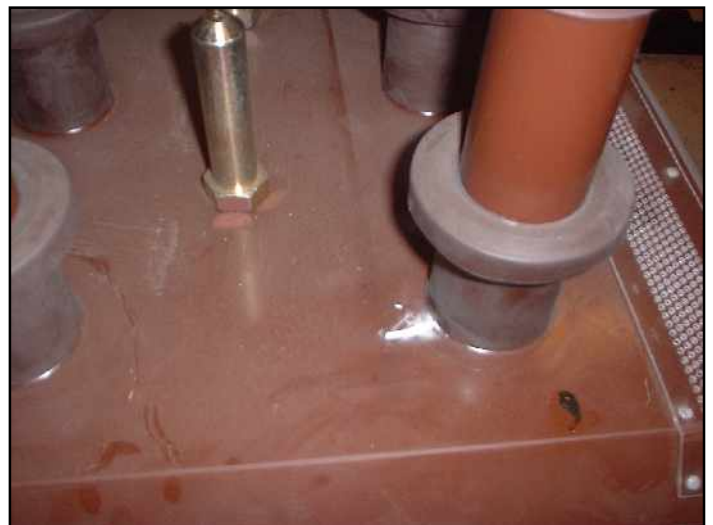
Following the survey an investigation was carried out. With the tank racked down the problem was clearly evident at the base of the right hand side cable bushing. The whole area was surrounded by white powder which is a usual by-product of discharge activity.

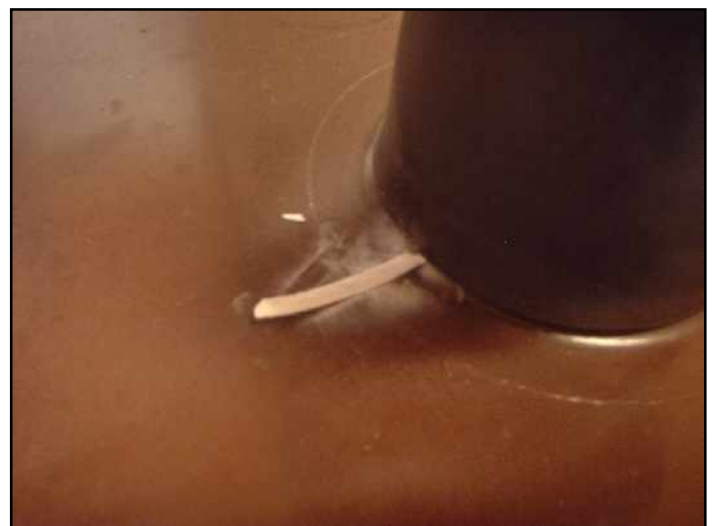
Closer inspection revealed some foreign debris on the surface of the resin next to the base of the bushing. It also seemed likely that there had been more than this one piece.

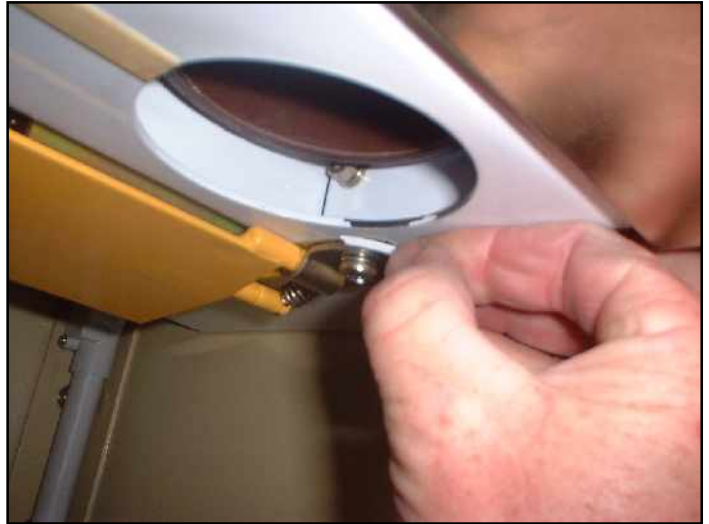
This debris was later identified as a flake of paint from the inside of the spout orifice plate, perhaps knocked free by either the shutter action or during incorrect orientation prior to racking up.

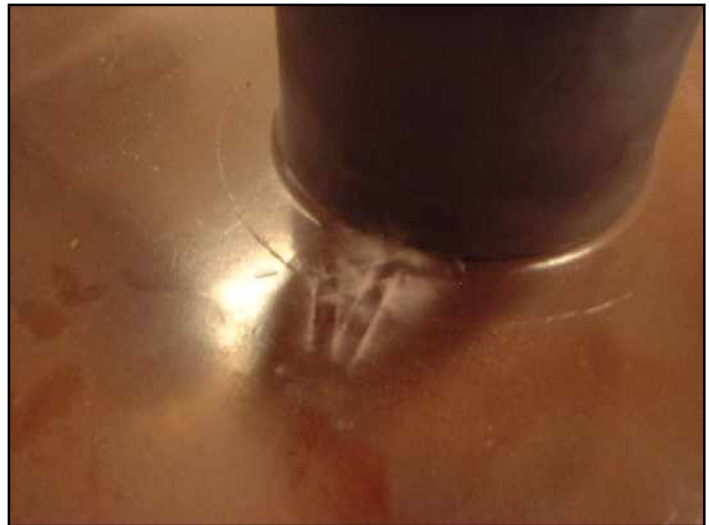
Prior to cleaning it can be seen how the discharge activity is predominantly along each edge of the paint flake. This highlights the need for resin to be kept clean and what an uneven electrical stress across it can cause.

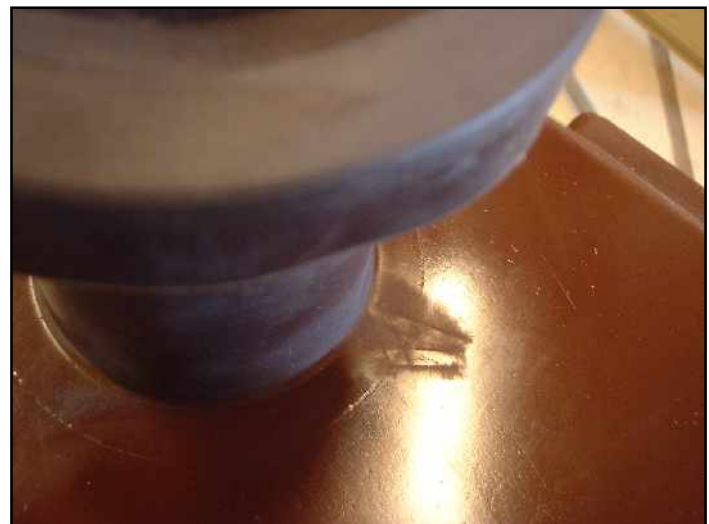
Preliminary cleaning shows how the surface has actually been etched into by the discharge action. The area was 'cut' with a fine abrasive and then polished to a high gloss finish. The two subsequent annual surveys have remained clear, proving the maintenance has been effective and a potential problem neutralised.
