PARTIAL DISCHARGE IN THE PACIFIC

By Greg Linton

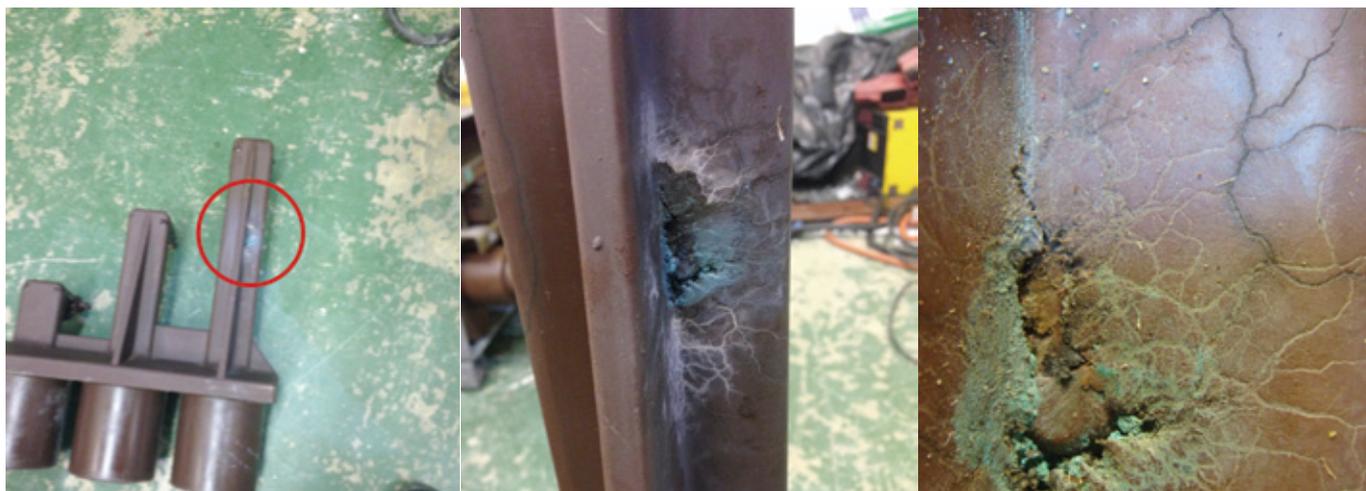
The epoxy-resin Busbar Monoblock located directly underneath the Voltage Transformer was discovered during the subsequent investigation and most notably, was exactly where the activity was reported.

TEV readings were not exactly what you might call excessive although a sub-surface 'void' or material imperfection cannot be ruled out as part of the initiation process, eventually manifesting

itself into the surface damage shown.

Ultrasonic discharge, usually the result of contamination to the insulating surface, inadequate clearances between live phases and/or earthed parts or sharp metal protrusions / lack of stress control was measured at 36dBuV, Gain 80 which is high enough to warrant an inspection as soon as it could be arranged.

With replacement of the deteriorating component completed, HV Diagnostic Services were also asked to assist with the sourcing of Spares, placing TPL in a strong position to respond to any similar future issues.
