DIAGNOSING SERVICE AGED CABLES

By Greg Linton, HV Diagnostic Services Ltd

During winter of 2005, the network company in South Canterbury, New Zealand commissioned an MV cable condition assessment project to determine the status of their existing underground network. The testing involved VLF Partial Discharge mapping of ten 11kV Transmission and Sub-transmission cables forming the backbone of their urban and CBD network. The data provided would form an integral part of their network planning towards a system reinforcement program.

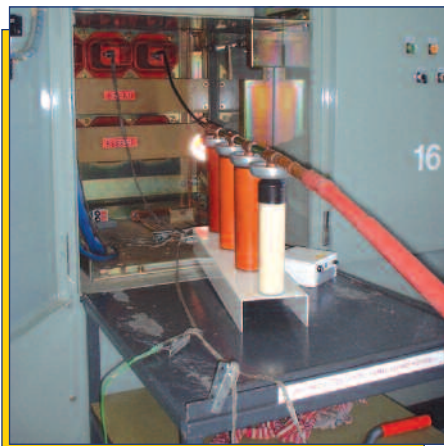
High Voltage test connection made through HF filter to core under test via switchgear cable spouts. The two phases not energised are earthed out allowing individual testing between phases and earth.

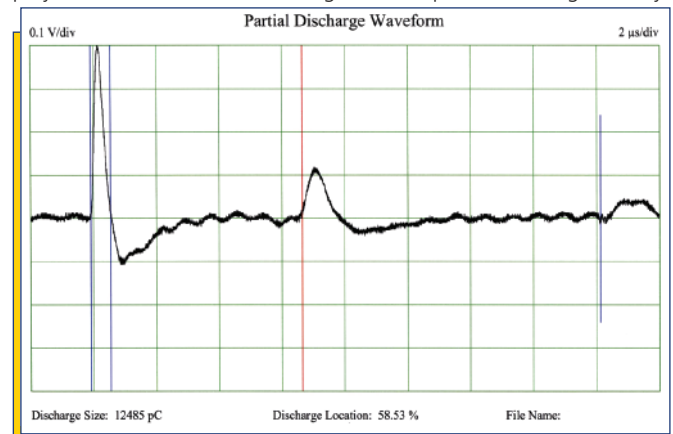
One single partial discharge event

The first 2 blue cursors mark the beginning of the cable and calculate the discharge amplitude. The red cursor locates its position along the cable and the final blue cursor marks the far 'open circuit' end of the cable.
