INTERMITTENT PARTIAL DISCHARGE DEMANDS A DIFFERENT PHILOSOPHY

CASE STUDY

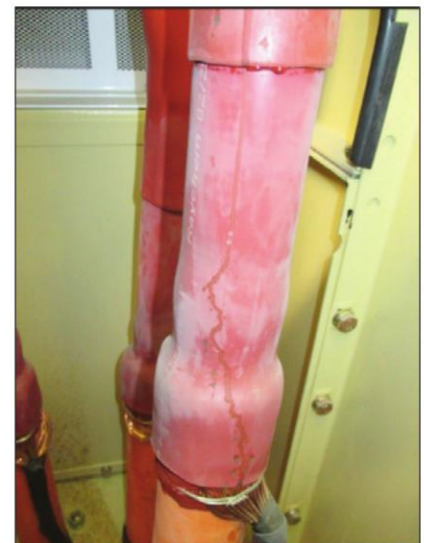
During the ensuing investigation, Water staining was evident on the termination sleeve along with signs of surface related tracking - the result of repetitive moisture ingress over an extended time frame.

Fortunately the damage was discovered at an early stage allowing for a Termination clean-up (and roof repair) rather than anything more invasive to remedy the problem.

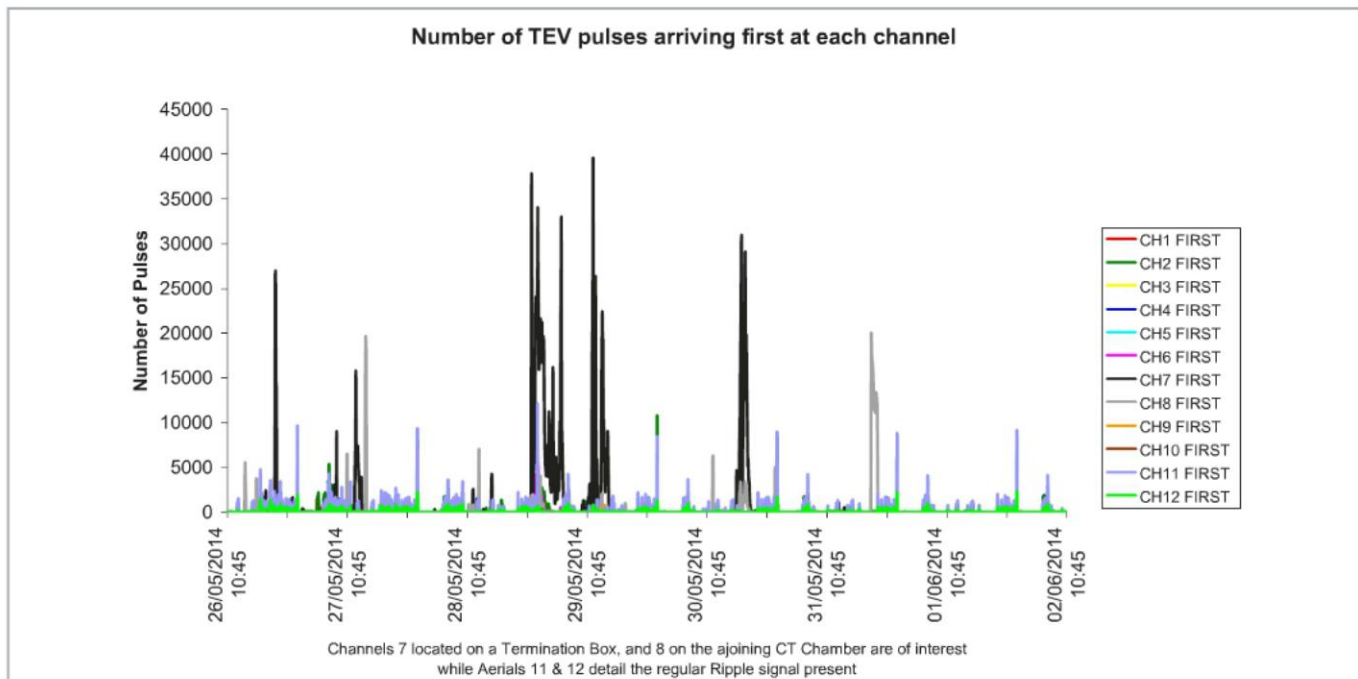
The Pulses 'first' graph illustrates the genuine TEV activity located on the Termination Box along with separate and lower levels of external interference

from the Local Ripple plant correctly apportioned to Aerials 11 and 12 (top right on adjacent page). It also conveys just how seldom it was present meaning one would be very lucky to strike it active during a 'spot visit'.
