# WHEN WERE YOUR VT FUSES LAST CHECKED?

*Both TEV and Ultrasonic need to be considered when attempting to identify Partial Discharge, and TEV Amplitude alone may not be an accurate indicator of the actual source due to the different signal pathways.*

**H**V Diagnostic Services was in Whangarei conducting regular 11kV Switchboard assessments of their local Zone Substations in October 2017. The Kioreora site containing aged BVP17 type switchgear exhibited both elevated TEV readings on one of the Incomers, and Ultrasonic activity from around the spouts of its installed Voltage Transformer.

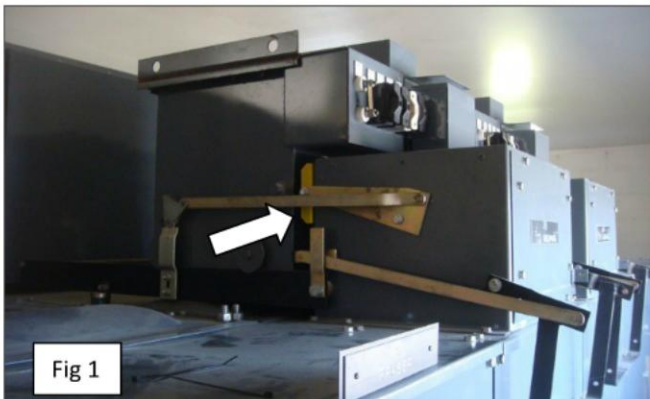
Fig 1

Ultrasonic activity (refer figure 1) was detected from the Blue Phase Bushing at 24dBuV at Gain 100, right on the cusp of requiring the Gain to be turned down, and further initiating the need for an

activity from its neighbour (refer figure 1) was now active with elevated TEV (influencing these retest values) and Ultrasonic present from the Red phase side, confirming it too would benefit from the same treatment.

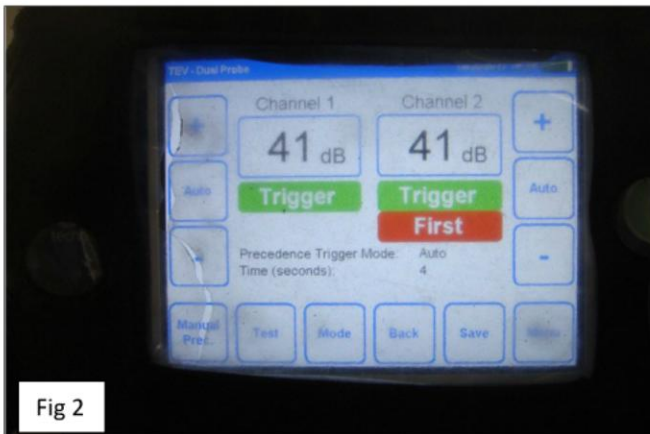
Fig 2

The Switch Tank (CB truck) exhibiting TEV of 44dBmV was the highest, and 30dBmV above the Background Metalwork reference while the VT and surrounding Trucks weren't far behind. Severity measurements were high (where anything greater than 100 is cause for concern); Switch Tank 950@6ppc and VT 612@6.12ppc while double probing for signal direction identified the VT as the source, figure 2(Channel 2 located on VT triggers first).

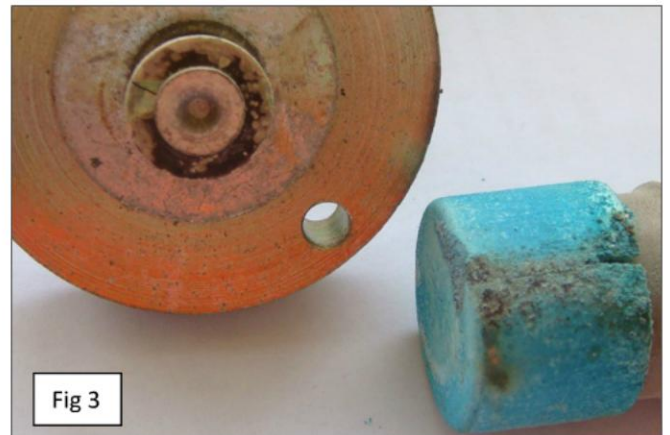
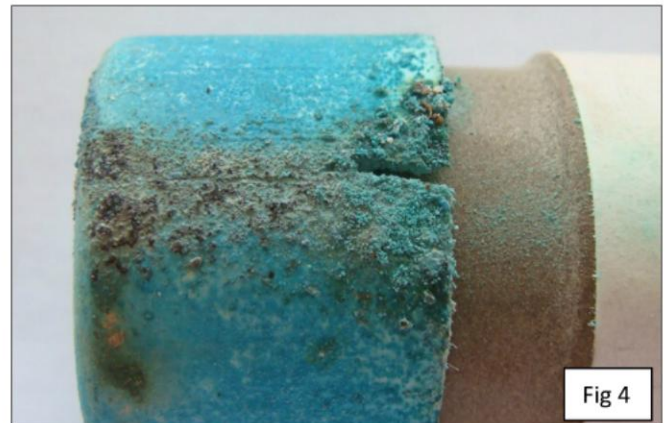
HVDS staff were on site during the outage to assist & advise, and as speculated the HV fuses and plunger butt contact were in extremely poor condition per figures 3 & 4.

Sometime later I mentioned my findings to EA Technology who were able to produce the Manufacturers original 'Inspection and Maintenance Procedure for Instrument Voltage Transformers' dated March 1998 which describes the possibility of electrical discharge to the moving portion contact assembly under certain conditions. A further modification was added in Nov 1999 which involved the introduction of a fine beryllium spring to the butt contact assembly improving electrical continuity between the retaining collar and plunger stem.

Fortunately some 'spares' were located within the Switchroom which looked as though they'd been there since day one which begs the question how often should these HV fuses be inspected over the course of a units lifetime? After a general clean-up they were ready to install and following restoration of the circuit a re-test confirmed that TEV readings had fallen significantly, the Switch Tank now 28dBmV, VT 34dBmV and Ultrasonic clear. However, similar

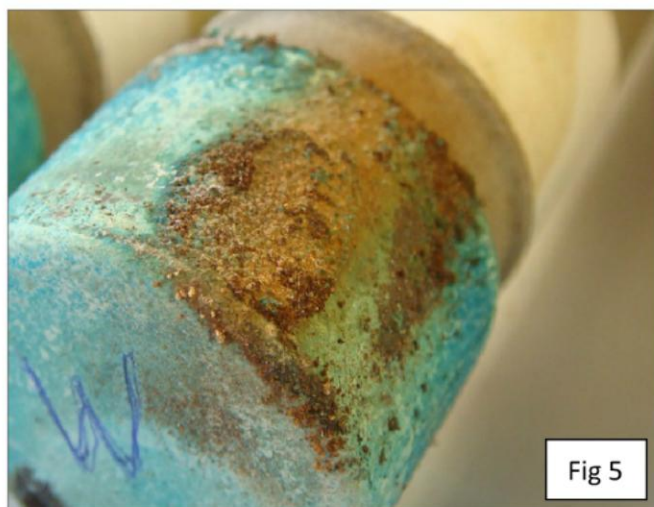
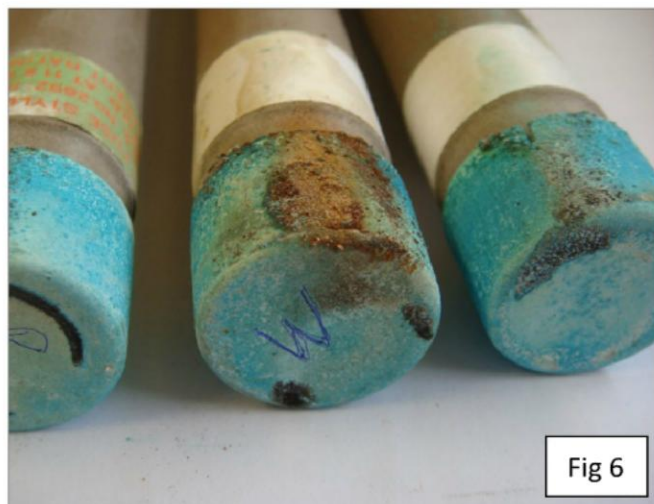
Upon sighting of the Blue phase fuse it was obvious that all three should be examined and unsurprisingly similar rates of surface deterioration were found on three of them (figures 5 & 6).
