Asset Failure – Covid and Other Extenuating Circumstances

This is the tale of two 11kV Switches of the same brand & model (although separated by several years) experiencing Partial Discharge around the Cables / Bushings with the first successfully identified and replaced mitigating a future catastrophic failure, the second unfortunately was not.

By Greg Linton of HV Diagnostic Services in New Zealand.

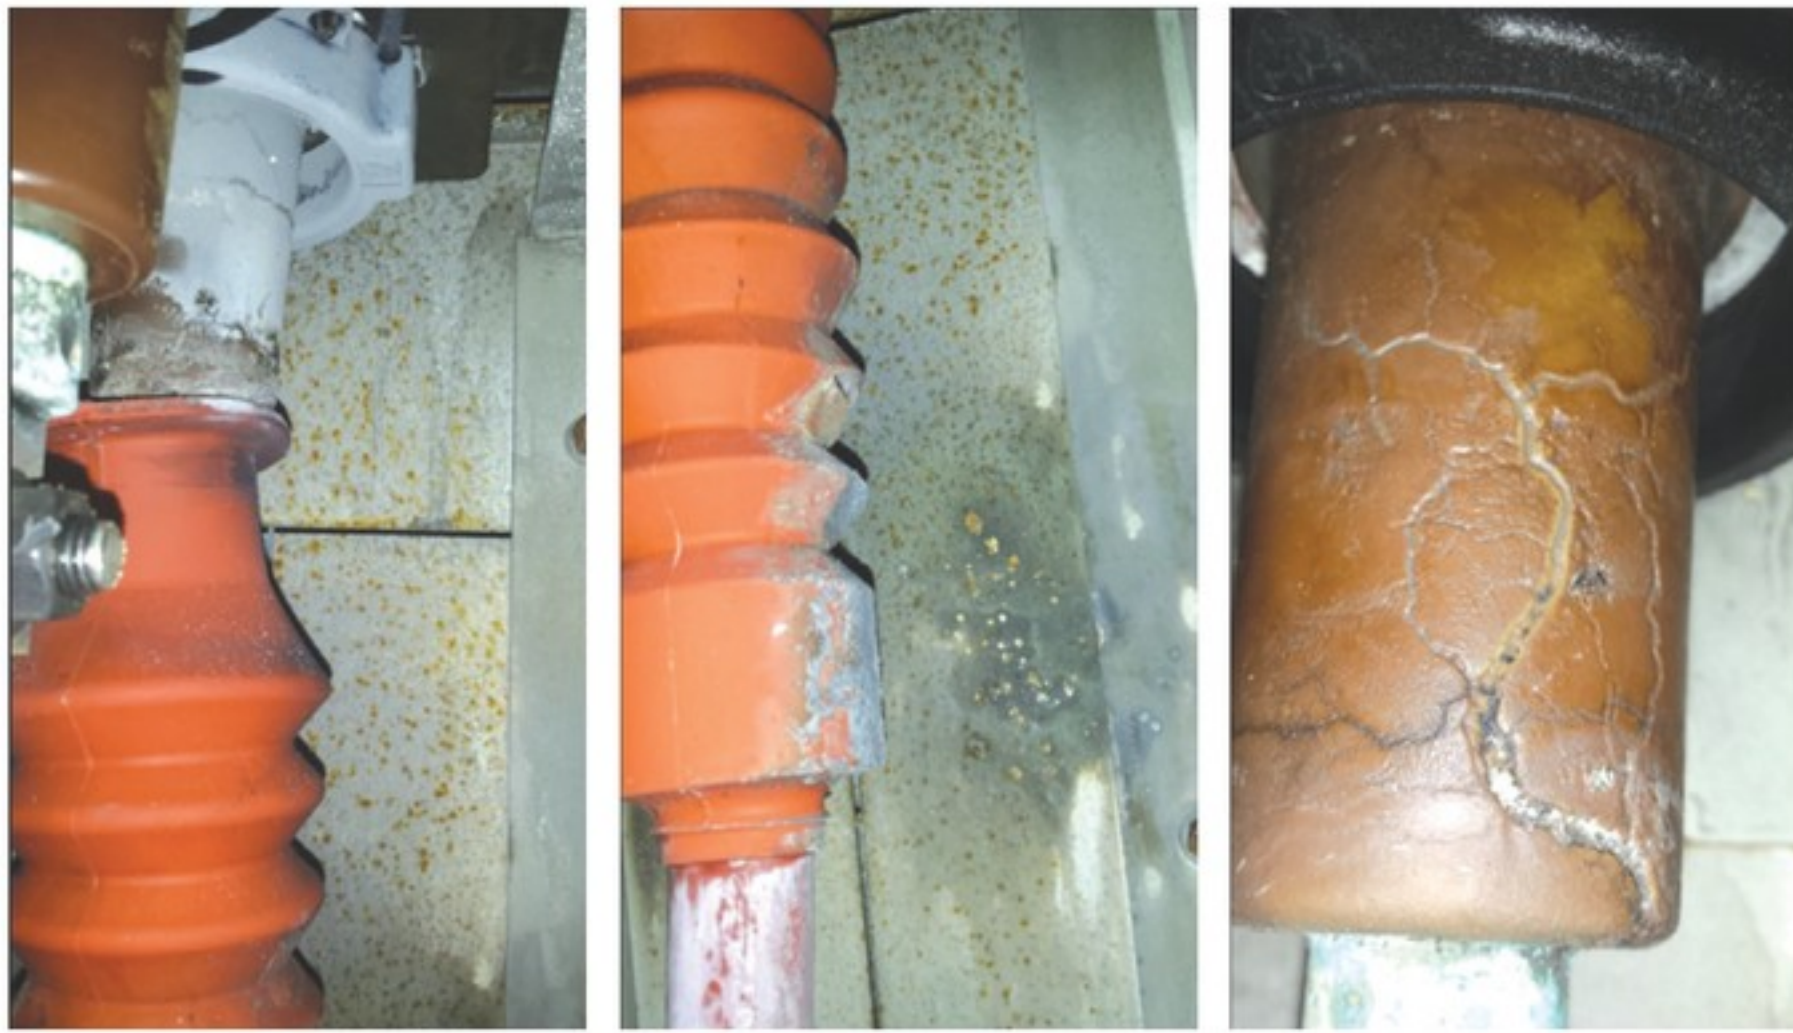
Switch No. 1 - Photos received from client April 2017

This first Switch originally featured in Issue 4 of 2017 and to recap briefly, was anecdotally 3 years old when the defect was identified. The circuit had suffered a nuisance trip earlier in the year however sectionalising and testing failed to reveal a hard fault and it was returned to service without further incident. Ultrasonic activity was subsequently detected by HV Diagnostic Services and upon investigation the damage found was too severe to rescue despite it having ‘hung-in’ live since

restoration (above). Detection was via EA Technology’s award winning UltraTEV Detector and although this basic instrument does not provide absolute values, with the Ultrasonic light Red we can say that a signal of at least 12dBuV above the instruments zero point was present.

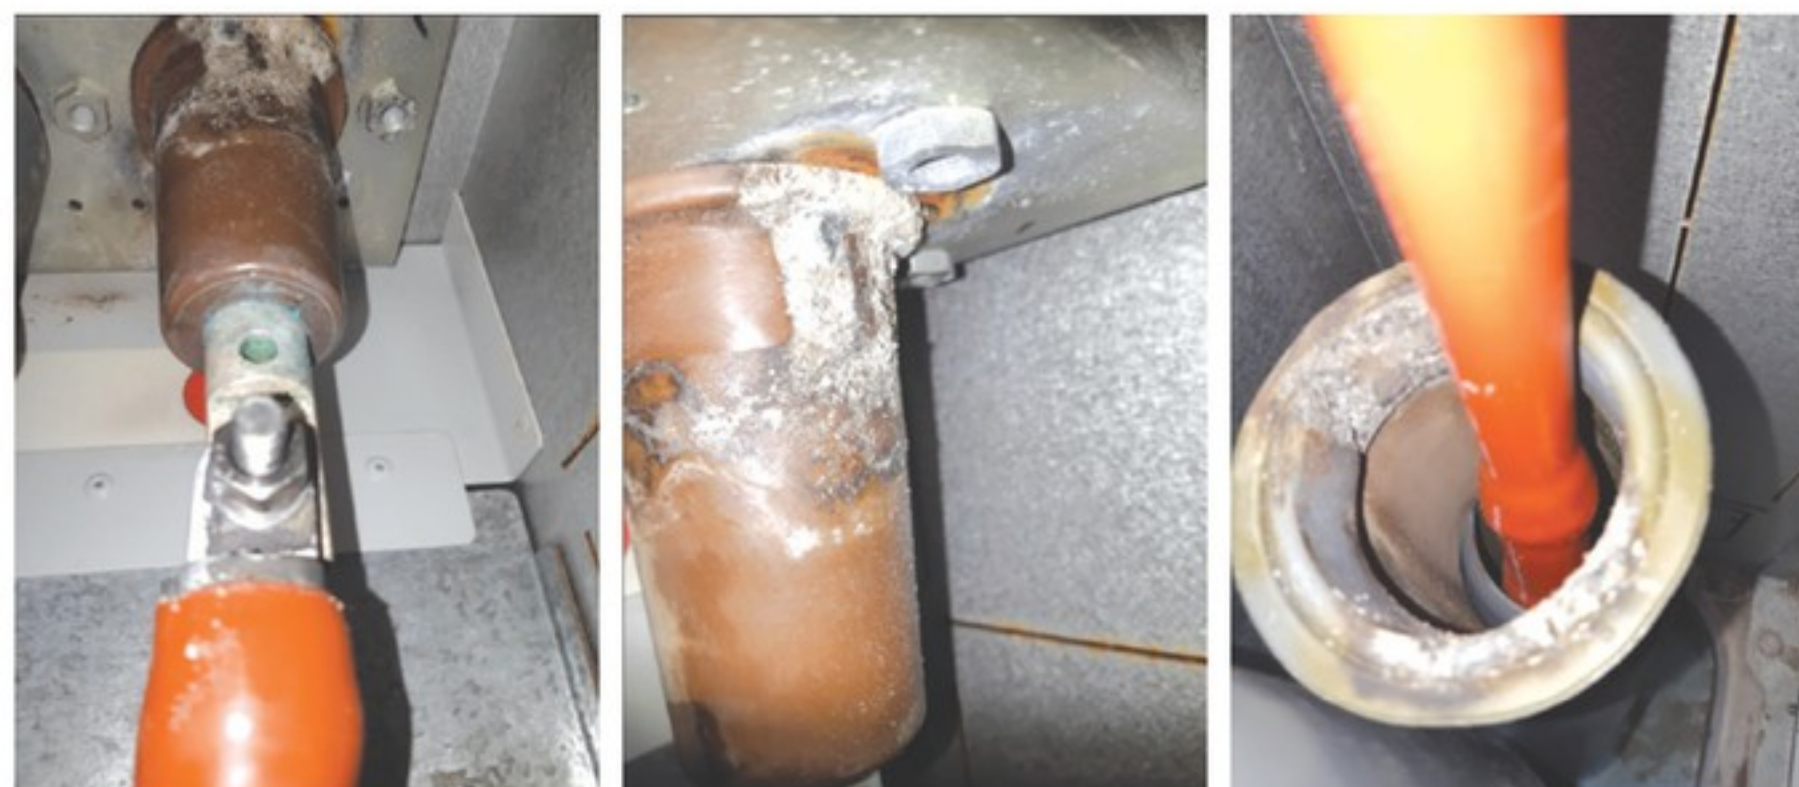
Subject No. 2 - Photos received from client December 2020

The second subject was similarly young - approximately 4 years old and ultimately failed on 21st December 2020 (below). There were

By the second half of 2020 with a lowering of Alert levels and domestic travel rebounding a full site survey was completed by HVDS in September and Ultrasonic Discharge measuring a maximum 22dBuV was identified from the Termination chamber. Turns out it was also reported in April the previous year and had been investigated during the 2019 winter season whereby a lack of gland plates allowed significant levels of condensation to form on Termination, Boot and Metalwork surfaces, all duly remedied. The phase plots opposite captured on both occasions by our own UltraTEV Plus² instrument display a similar likeness with subtle ‘peaks’ present 180 degrees apart confirming genuine surface Discharge, while the instruments own internal classification algorithms indicate ‘PD’ rather than ‘noise’.

Investigation findings from the Network Owner revealed waste water pipes running close to the cable ducts under the switchgear seemingly responsible for the condensation problems while the corrosion itself was considered to be chemical affected. Fortunately, a replacement switch was on hand minimising length of outage and a further check in February 2021 by HVDS confirmed a clear result however regular monitoring through continued

online surveys will be crucial to prevent any reoccurrence.

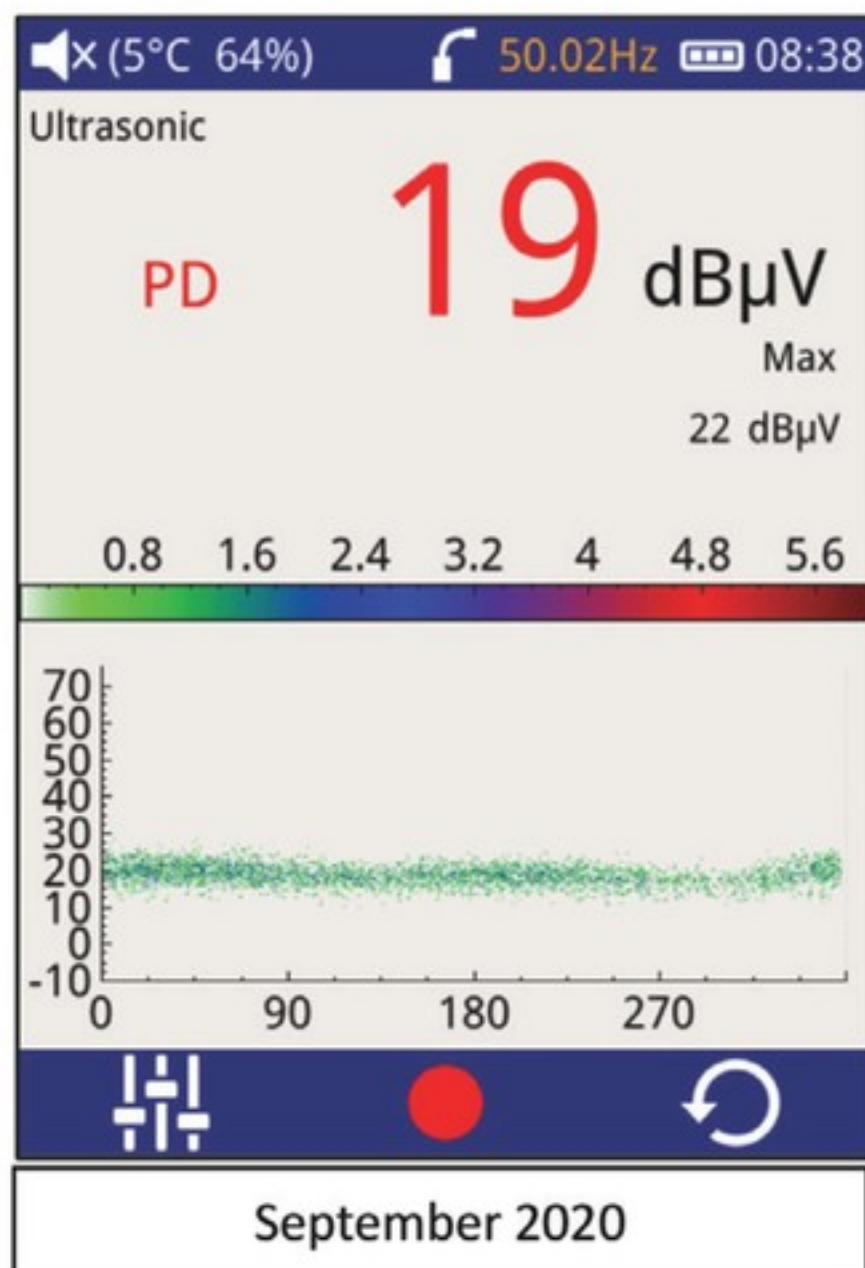
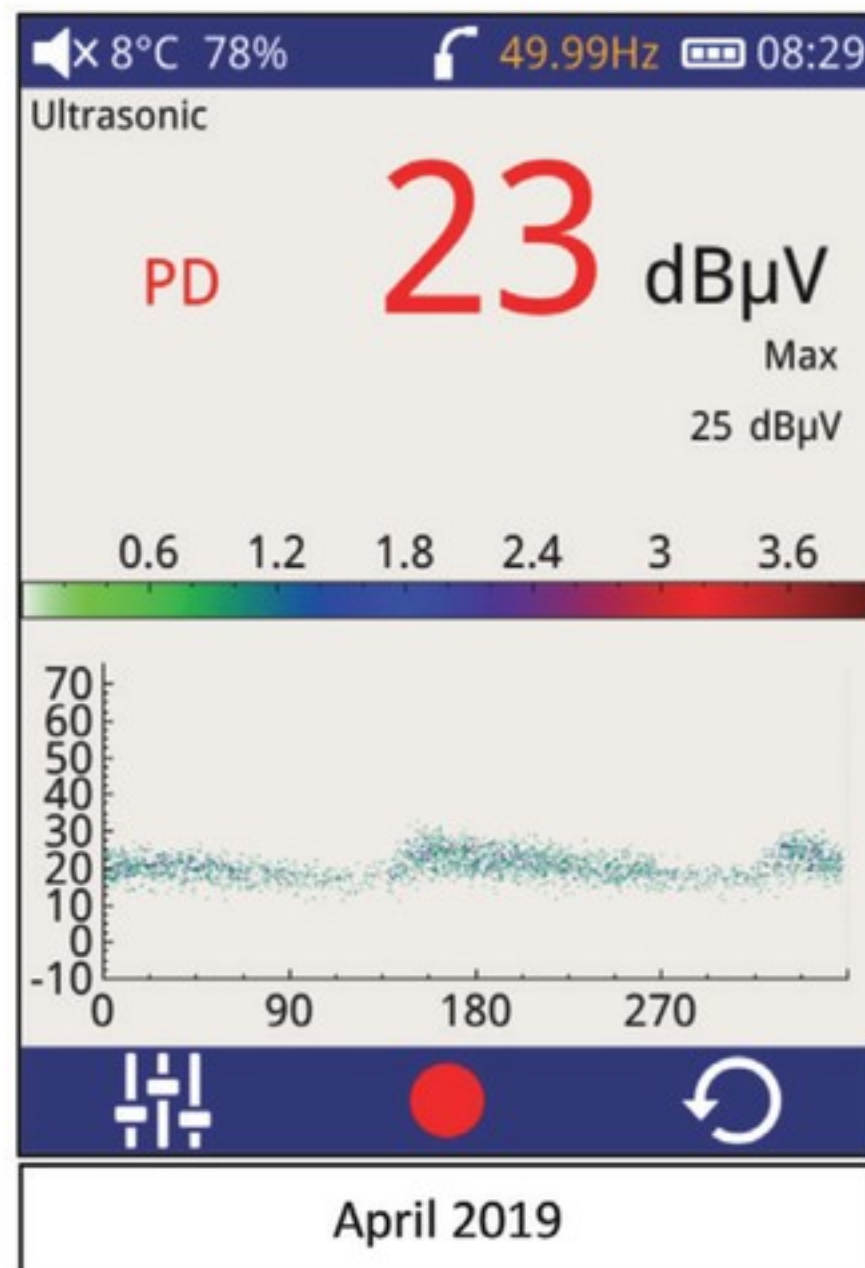
Surface discharges are influenced by external stimuli and can lie dormant for long periods waiting for the ‘right’ conditions to become active, and unlike TEV activity don’t often exhibit trend-able behaviour meaning failure can occur from seemingly innocuous levels of activity. Emissions can generate aggressive by-products quickly degrading an insulator’s dielectric properties leading to rapid escalation and disaster.
