FINDING PARTIAL DISCHARGE IN SWITCHYARDS

This paper focuses on unwelcome external sources of Partial Discharge from a Switchyard, their impact on TEV measurement indoors and the subsequent successful identification & solution to the dilemma.

By Greg Linton, HV Diagnostic Services Limited

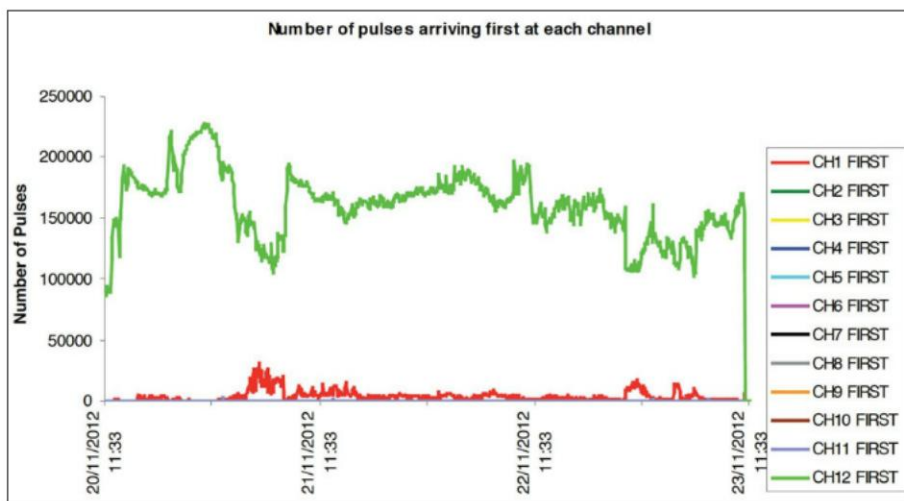
Continuous Activity logged inside over 3 days of Monitoring, high pulse count.

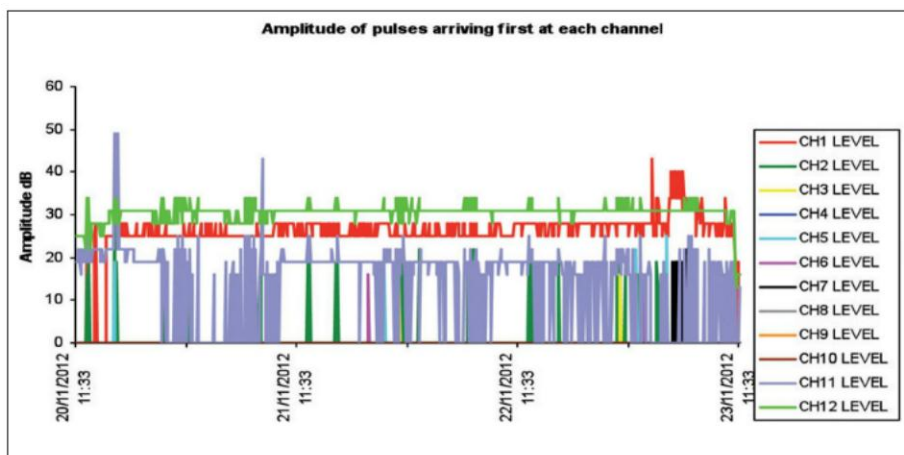
CH 1 & 12 (together with 2 & 11) are Aerials positioned along wall forming a perimeter between indoors and out.

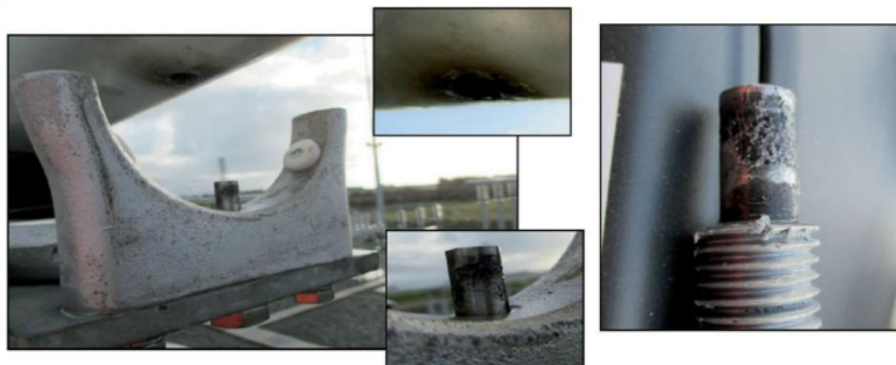
The resultant investigation exposed a deficiency within the pin/bolt not making a positive connection into the Bus, possibly due to being too short and allowing discharge to occur between unbonded points of differing potential, with carbonisation and pitting clearly evident to the metal parts. (Shown previous page.)

Upon remedying the situation, TEV Location survey results inside immediately improved and have remained low now for consecutive site visits, note the reduction to the Background Air & Metalwork reference and the positive effect on switchboard levels. (see survey tables)

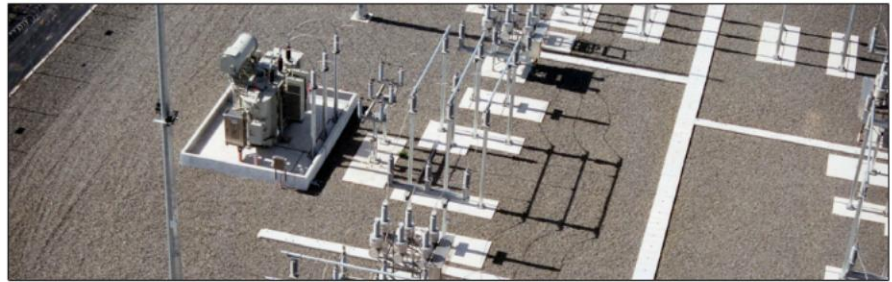
September 2012 – typical up to that point

AIR		6		METALWORK				23		TEMPERATURE		22°C	
	SWITCH POSITION (OPEN, CLOSED, EARTHED, ABSENT)	BUSBAR 1 UPPER/FRONT	BUSBAR 2 LOWER/REAR	SWITCH TANK	CT CHAMBER	VOLTAGE TRANSFORMER	TERMINATION BOX	BAND JO /END CA		BUSBAR 1			
1 Rd	C	15		22	21		22						
	C	15		22	23	18	20						
	C	14		18	21	18	18						
51	C	17		16	20		20						
	C	9		17	20		-						
	C	14		12	18		21			13			
	C	8		13	19	11	22						
	C	10		16	18	12	18						
1 Rd	C	13		14	17		24

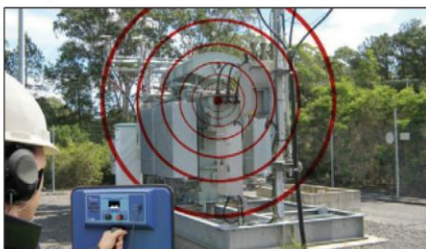
September 2013 – the new benchmark here

AIR		Clear		METALWORK				0		TEMPERATURE		17°C	
	SWITCH POSITION (OPEN, CLOSED, EARTHED, ABSENT)	BUSBAR 1 UPPER/FRONT	BUSBAR 2 LOWER/REAR	SWITCH TANK	CT CHAMBER	VOLTAGE TRANSFORMER	TERMINATION BOX	BAND JO /END CA		BUSBAR 1			
1 Rd	C	3		1	3		7						
	C	2		1	4	3	6						
	C	3		2	2	2	4						
51	C	2		3	2		5						
	C	2		2	2		-						
	C	3		6	3		5			3			
	C	3		2	2	3	5						
	C	3		2	3	3	6						
1 Rd	C	3		12	2		5
